Green Hills – Maple and Kelly Canyons

Conservation Easement Monitoring Report and Photo Record 2025

Property Name: Green Hills Maple Canyon and Green Hills Kelly Canyon		Acres: 545 Ac (Maple Canyon) 436.75 Ac (Kelly Canyon)
Acquired Date: 11/12/1998 (Maple) 8/20/1999 (Kelly)	Monitoring Date: October 17 and 21, 2025	
Location: East side of Ogden Valley in and around the Green Hills homeowner community.

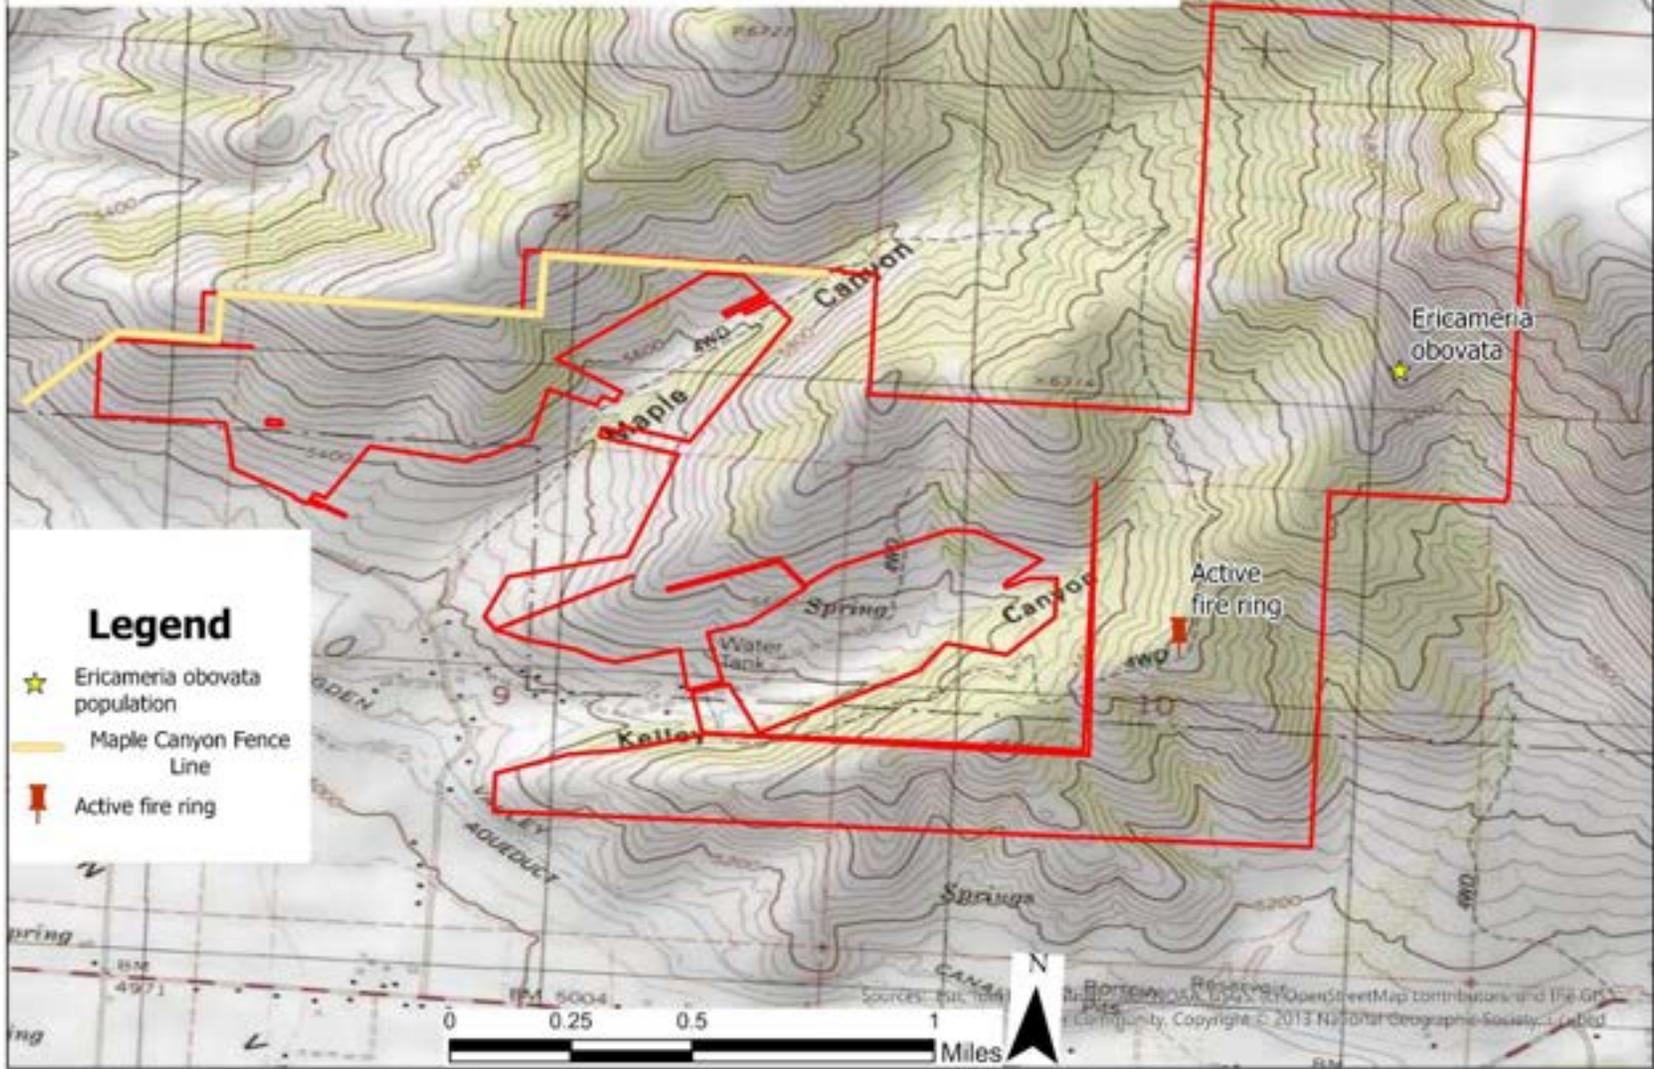
Figure 2. Green Hills Conservation Easement Points of Interest

New fence has been constructed on the north and west side of the Maple Canyon easement (Figure 2 and Maple Canyon Photographs 53, 55, 58-61).

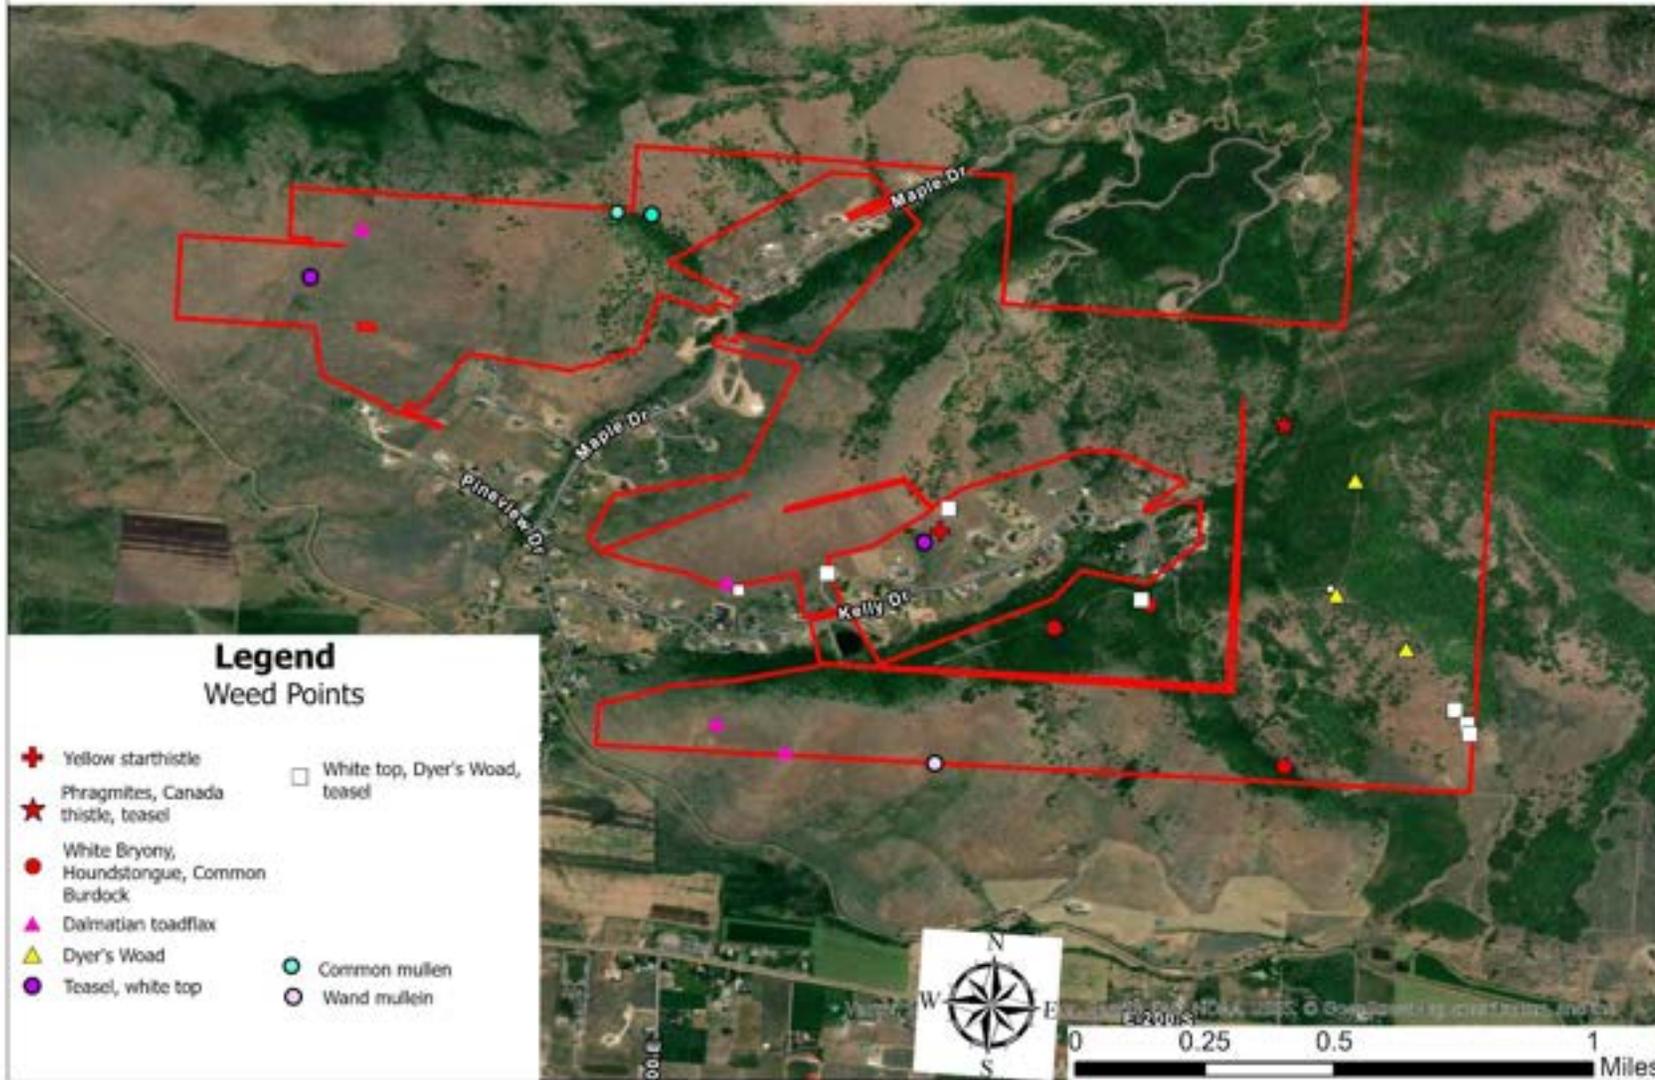
Figure 3. Weed Points

In support of the easement’s purpose to maintain and enhance wildlife habitat, it was noted that state-listed noxious weeds are present on the property. Regular monitoring and control of invasive plant species are recommended to prevent further spread and degradation of habitat values. Timely management is essential to maintain compliance and ecological value. State-listed noxious weeds observed include: *Isatis tinctoria* (Dyer’s Woad), *Cardaria draba* (White top), *Cirsium arvense* (Canada thistle), *Linaria dalmatica* (Dalmatian toadflax), *Phragmites australis* (Common reed), and *Centaurea solstitialis* (Yellow starthistle) (Figure 3 and Kelly Canyon Photographs 105-109). It should be noted that the Yellow starthistle was located just outside of the perimeter of the Kelly Canyon conservation easement, close to the neighborhood, but is a source for spread. Additional non-state-listed but concerning invasive species observed include: *Dipsacus fullonum* (Common teasel), *Arctium minus* (Common burdock), *Verbascum thapsus* (Common mullein), *Verbascum virgatum* (Wand mullein) and *Bryonia alba* (White bryony) (Figure 3 and Kelly Canyon Photographs 101 and 104-109).

The most concerning of these finds is the yellow starthistle – as that weed is known to expand its infestation rather quickly and aggressively at the expense of desirable vegetation (Figure 3 and Kelly Canyon Photograph 107).

It is recommended that the landowner contact the designated Utah Division of Wildlife Resources (UDWR) representative, Melissa Early (mearly@utah.gov), to work with the state’s ISM (Invasive Species Management) grant program in hopes of receiving both expert and financial assistance to develop a noxious weed plan as well as active treatment of noxious weeds.

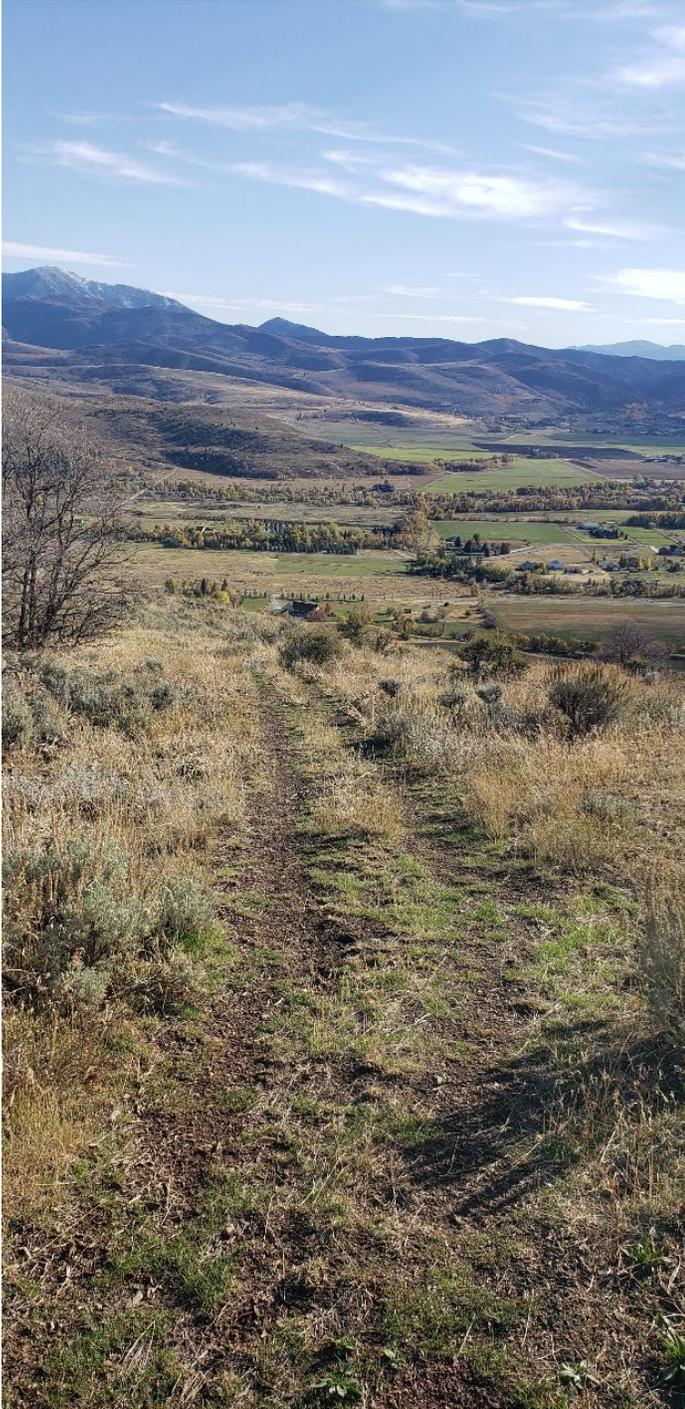
Kelly Canyon - Photo 103

Note: South facing slopes in poor condition (weedy)

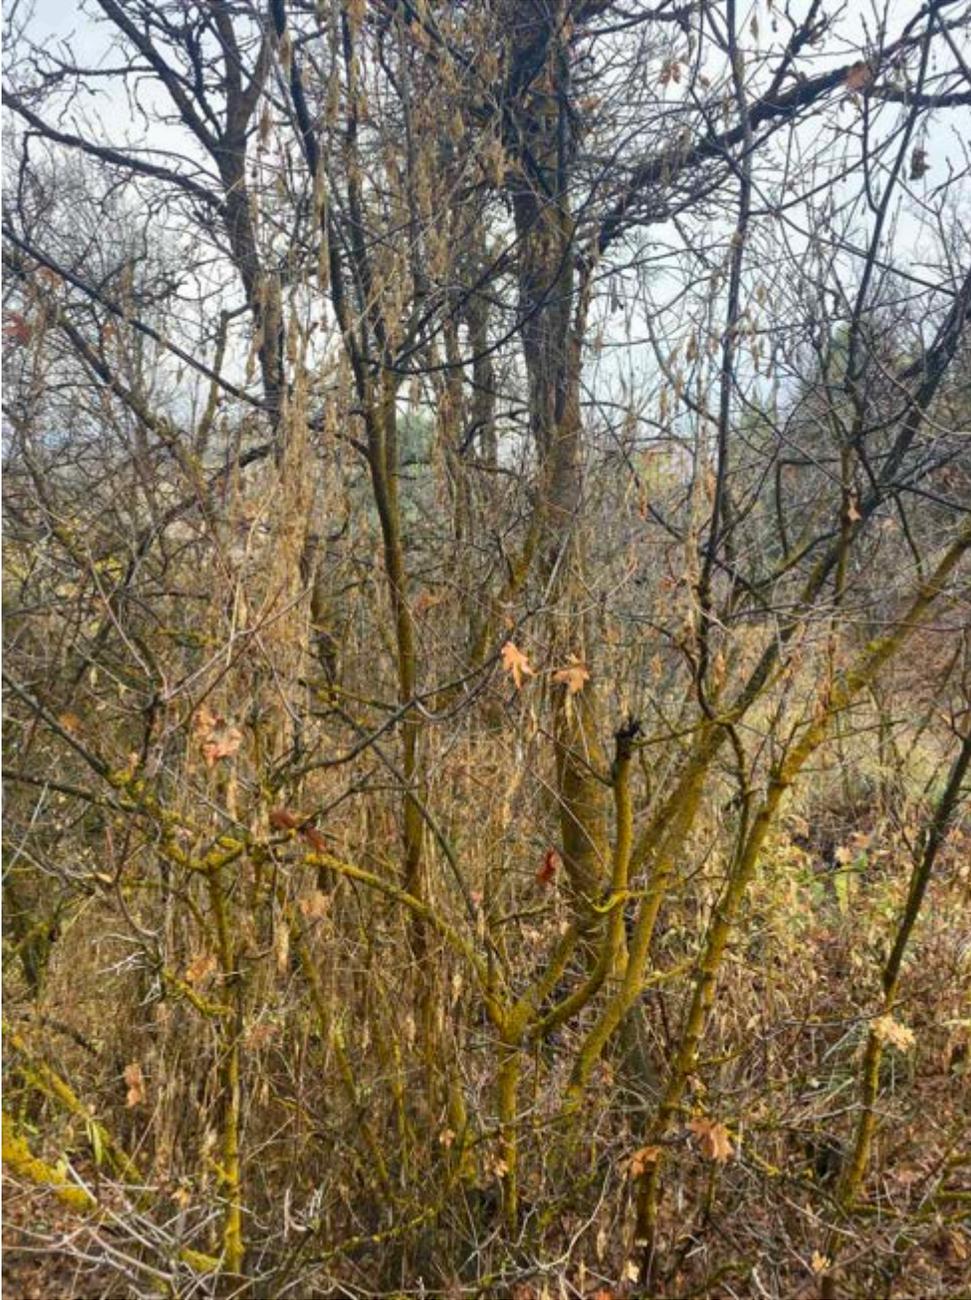
Kelly Canyon - Photo 105

105	KC Extra	440062.188	4569253.641	Weeds - White Bryony, houndstongue, common burdock throughout curve in road
106	KC Extra	439529.836	4569401.523	Weeds - Teasel dominating natural spring, surrounded by whitetop and cheatgrass (weed source bordering CE)
107	KC Extra	439564.777	4569439.425	Weeds - Yellow starthistle near yellow toadflax infestation - Weed source bordering CE
108	KC Extra	440829.861	4568915.63	Weeds - Dyer's woad- radius of 50ft, within dead sagebrush
109	KC Extra	440353.757	4569836.582	Weeds - dense stands of teasel, Phragmites, and Canada thistle
110	KC Extra	440484.3	4569337.7	Active fire ring

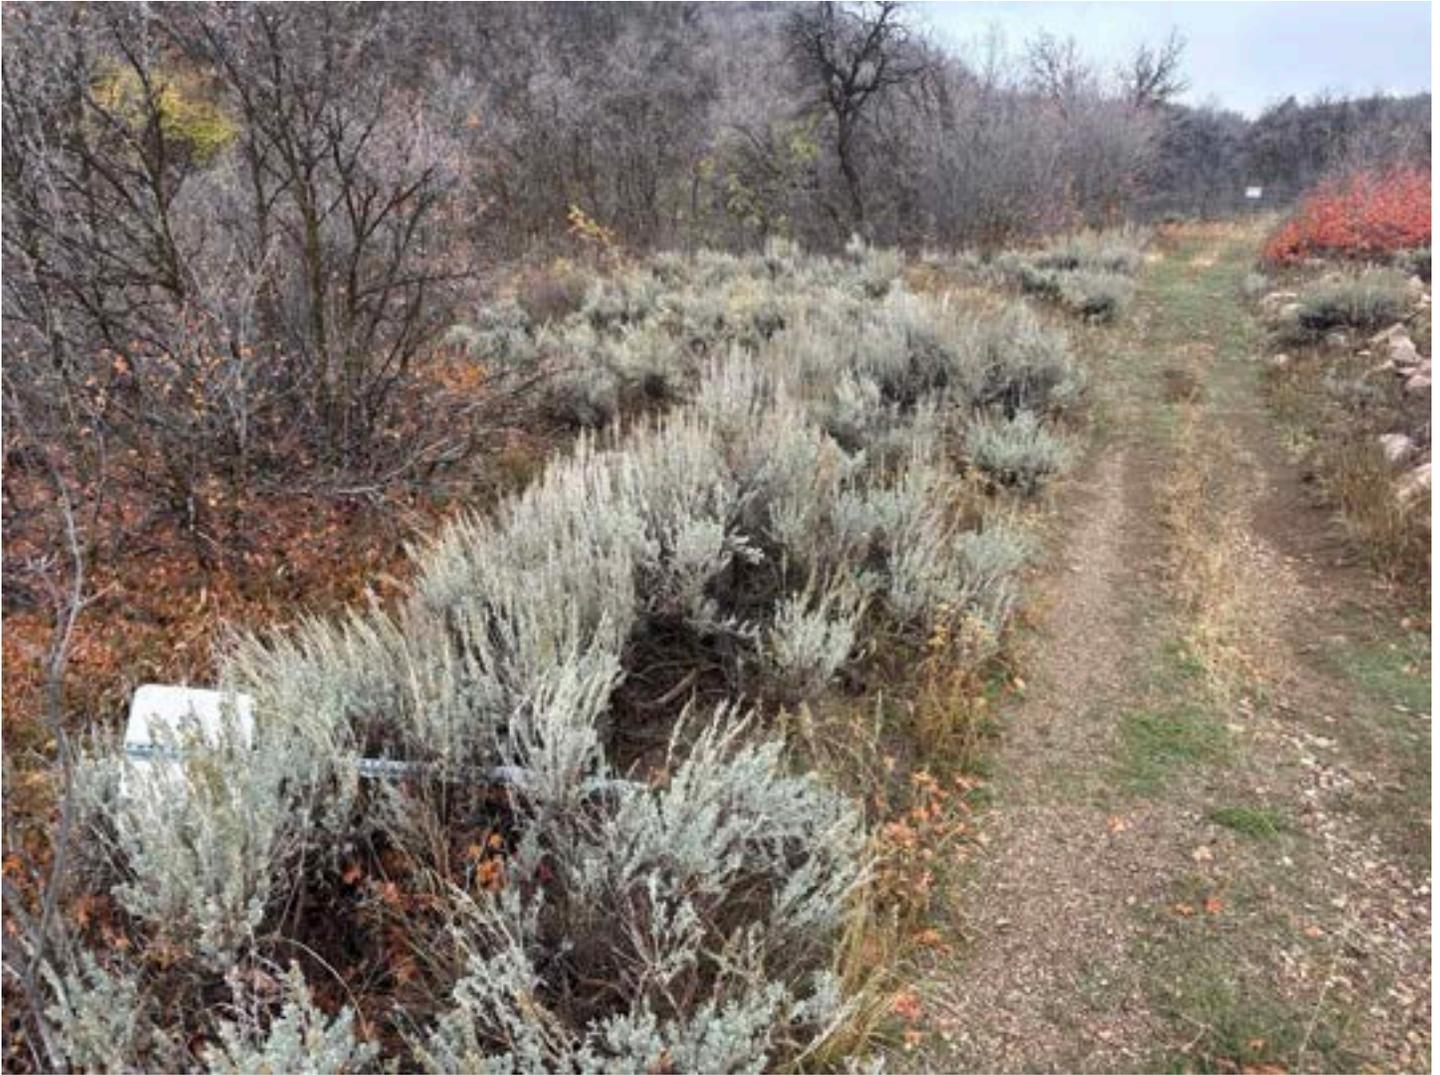
Maple Canyon - Photo 89

Note: Sign was knocked over and had bullet holes in it.

Category	Compliance Summary	Comment
Purpose	Yes, with note	The purpose of the Property, as outlined in Section 1, is to maintain wildlife habitat and open space. These uses appear consistent with current conditions.
Administrative Access	Yes,	No public access is granted with this Conservation Easement.
Fence Construction & Maintenance	Yes	A new fence has been installed along the north west boundary of the Maple Canyon property (Figure 2 and Maple Canyon Photographs # 53,55, and 58-61).The CE document states: "Fencing or rock barriers will be constructed and maintained by the Grantors on the Property boundary, adjacent to private lots or roads in developed portions of Green Hills subdivision
Signs	Yes, with note	Access signage should be installed to clearly identify the property (Maple Canyon Photopoint LL, Photograph 89-90).

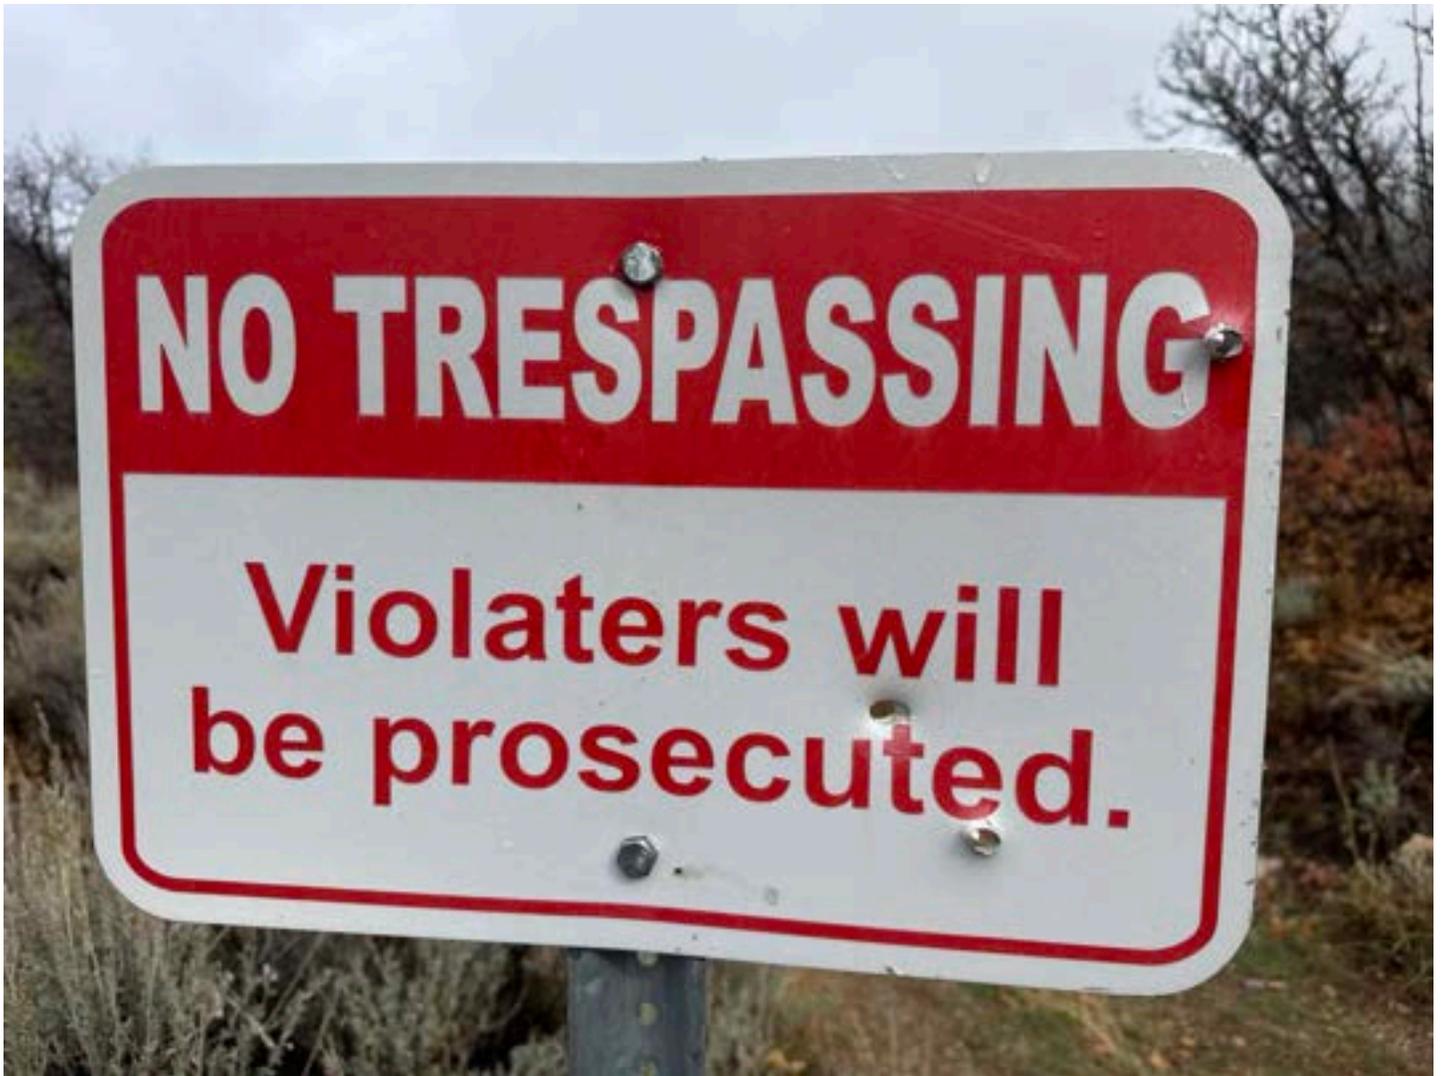
Maple Canyon - Photo 90

Note: Sign was knocked over and had bullet holes in it, sign was propped back up but probably needs further attention.
